# TURBOCHARGER:

DAMAGE PROFILES, CAUSES, AND PREVENTION

Technical information

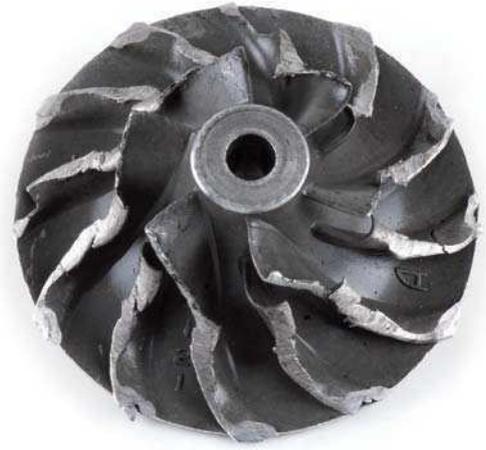
- The impeller and turbine wheel can strike the turbocharger housing on account of bearing damage (Fig. 1). This can be discerned from wear marks on the housing (Fig. 2).

Fig. 1  
Impeller after contact with housing

- The engine must be warmed up and cooled down.
- The engine must be supplied with enough oil.
- Only engine oils specified by the vehicle or engine manufacturer may be used.
- Only driving short distances should be avoided.
- The maintenance intervals according to the manufacturer's recommendations should always be complied with.
- Only high-quality oil filters specified for the respective vehicle should be installed.
- The corresponding mounting kit for the turbocharger must always be used.
- When operating the engine with biodiesel or vegetable oil, the service intervals should at least be halved.

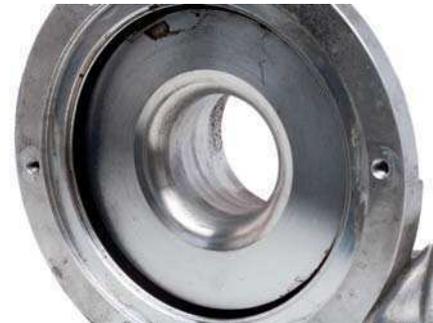
Fig. 2  
Contact marks in the compressor housing

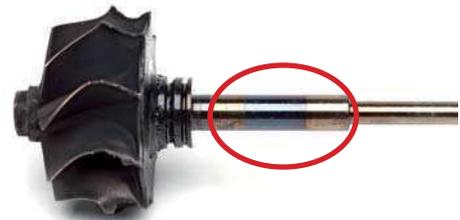
- The shaft shank exhibits clear discoloration (Fig. 3), which arises from friction and the resultant high temperatures between the shaft and the bearings. The cause of this is inadequate lubrication. If the temperature exceeds a certain level, the bearing material will become deposited on the shaft (Fig. 4) or the bushing might even become completely fused to the shaft.

Fig. 3  
Discoloration of the shaft shank

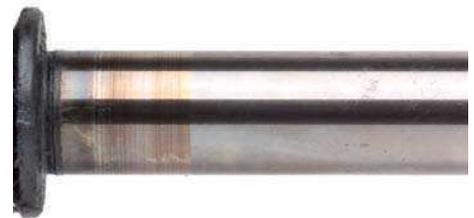
Fig. 4  
Bearing material fused onto the shaft

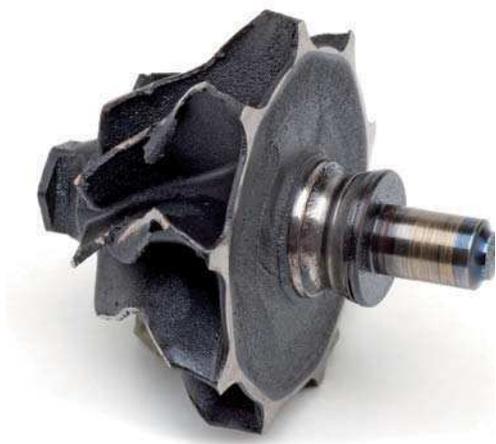
- A broken shaft shank (Fig. 5) is the result of operating the turbocharger for a prolonged time without enough oil. The shaft material can thus burn out and break.

Fig. 5  
Broken shaft shank

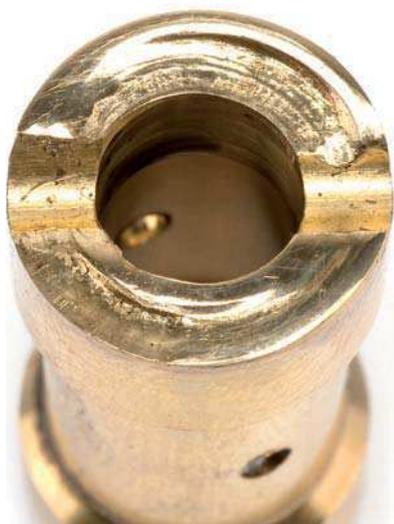
- If bushings that are permanently incorporated in the bearing housing become fused to the shaft, the bushings might turn out of position in the bearing housing (Fig. 6).

Fig. 6  
Twisted bushing

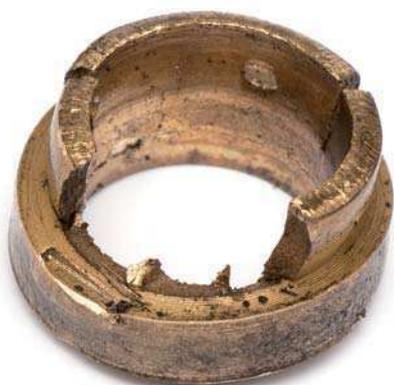
- The rotating assembly can exhibit a large imbalance owing to the contact with the housing, which might result in the radial bearing breaking (Fig. 7).

Fig. 7  
Broken radial bearing

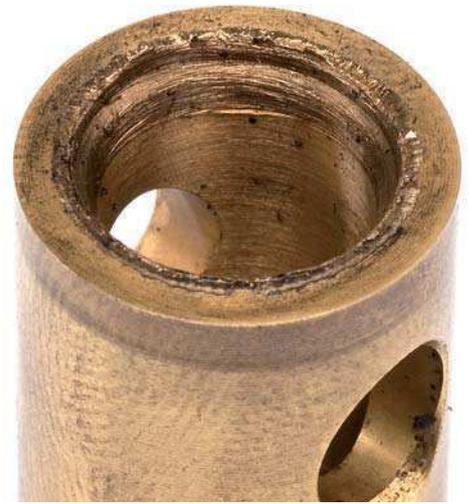
- The smallest foreign substances in the oil cause grooves in the bushings (Fig. 1). The piston rings in the turbocharger can undergo serious wear. As worn piston rings can no longer adequately seal the turbocharger, the oil enters the turbine side, which can be discerned by increased oil consumption.

Fig. 1  
Grooves in the radial bearing

- The maintenance intervals according to the manufacturer's recommendations should always be complied with.
- Only high-quality oil filters specified for the respective vehicle should be installed.
- Only engine oils specified by the vehicle or engine manufacturer may be used.
- A new charge air cooler and air filter should always be installed when replacing the turbocharger. In addition, an oil change including oil filter replacement must be carried out.
- The air filter housing and charge air line should be cleaned by suction.

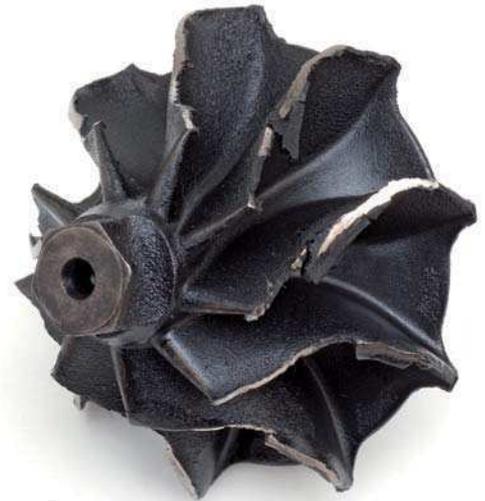
- The bearing play of the rotating assembly increases due to the worn bushings. This leads to wobbling movements and causes the turbine wheel or impeller to come into contact with the housing (Fig. 2). The shaft might subsequently break off.

Fig. 2  
Turbine wheel after contact with housing

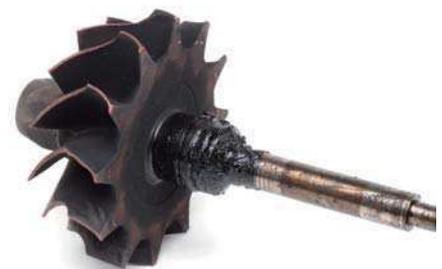
- The bearing collar, i.e. the thrust washer of the axial bearing, exhibits grooves.
- Grooves or fretting marks are discernible in the axial bearing.
- Due to a blocked oil return line, the oil in the turbocharger can no longer flow off and is instead forced out to the compressor and turbine side. On the turbine side, the oil might then burn onto the shaft and coke (Fig. 3). Owing to the oil carbon layer, the bearing housing and the piston rings might be significantly worn off as a consequence.

Fig. 3  
Carbonised oil on the turbine side

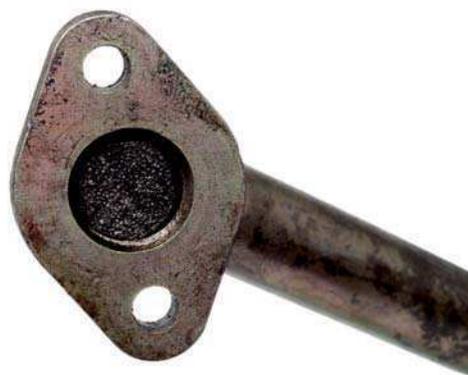
- If the oil return line of the turbocharger is clogged (*Fig. 1*) or constricted by a kink, the oil can no longer flow out of the turbocharger (*Fig. 2, diagram B*). A possible cause for clogged oil return lines is the coking of the return line, which might be due to missing heat shields, a poorly routed return line, heat soak, inadequate oil quality, or the use of liquid sealants. As the turbocharger is still supplied with oil from the engine circuit, the oil then escapes to the turbine or compressor side.

*Fig. 1*  
Carbonised oil return line

- The engine must only be filled to the specified maximum oil level.
- Only engine oils specified by the vehicle or engine manufacturer may be used.
- The oil return line must be routed exactly as in the original state. In addition, it must be ensured that all heat shields are attached.
- The oil return line and the connections to the crankcase must be checked for continuity. We generally recommend replacing the line and the connecting piece.
- The crankcase ventilation must be checked and replaced, if necessary.
- The piston and piston rings must be checked for wear and replaced, if necessary.
- A new charge air cooler and air filter should always be installed when replacing the turbocharger. In addition, an oil change including oil filter replacement must be carried out.

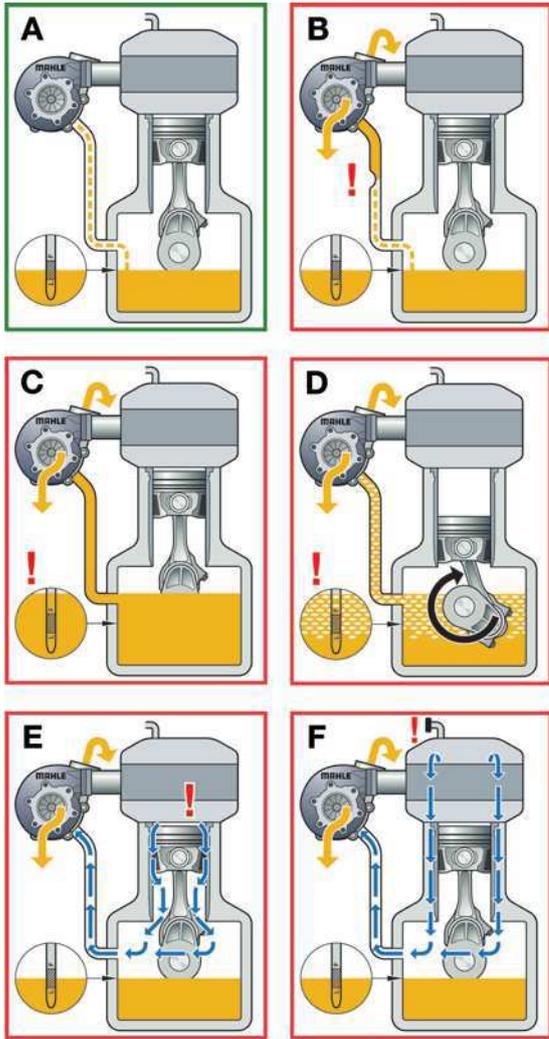
- If the engine is supplied with too much oil, the oil can no longer flow back out of the oil return line into the oil pan (*Fig. 2, diagram C*). The crankshaft also splashes up the oil. This results in the oil foaming, which forms an additional barrier for the returning oil from the turbocharger (*Fig. 2, diagram D*).

- If the pressure in the crankcase is too high—either because of too high blow-by (*Fig. 2, diagram E*) or due to blocked crankcase ventilation (*Fig. 2, diagram F*)—, this pressure will also be transferred to the oil return line of the turbocharger. The oil drainage from the turbocharger is thus hindered, and the oil escapes from the turbine or compressor side.

Fig. 2  
Oil leakage at turbocharger. Diagram A shows the optimum state.

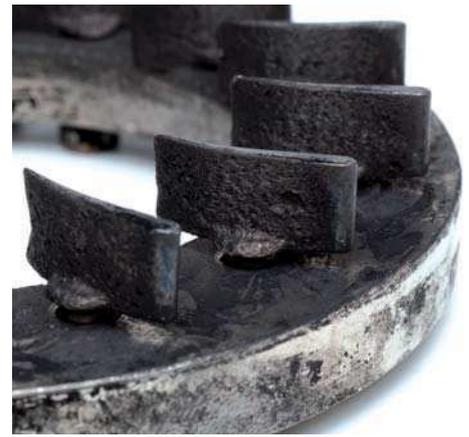
- On account of previous damage, foreign substances from the engine or the exhaust manifold can damage the gas entry edges of the turbine wheel.
- The air guide plates of the VTG unit are damaged and bent (*Fig. 1*), leading to a significant power loss.
- Foreign substances in the intake air result in damage to the impeller (*Fig. 2*). The vanes might become completely worn as a result. In addition, the intake passage of the compressor housing might be damaged (*Fig. 3*).
- The impeller might be damaged by condensation frozen in the intake section. Damage to just one vane is characteristic of this cause: owing to the high speeds, the ice particles burst when encountering the first vane, with no other vanes being damaged (*Fig. 4*).

- If a valve is torn off or the piston rings fracture, for example, these parts come into contact with the guide vanes of the VTG unit and the turbine wheel via the exhaust manifold.
- Both a leakage in the intake section and a contaminated or defective air filter can be the cause of penetration by foreign substances in the intake section.
- In winter, ice can form through condensation in the intake section.

*Fig. 1*  
Damaged air guide plates of the VTG unit

- The leak tightness of the intake section must be guaranteed.
- After working on the intake section, it must always be ensured that no loose parts remain there.
- The air filter must be replaced as specified by the manufacturer, and the air filter housing as well as charge air line should be cleaned by suction.
- Only driving short distances should be avoided.

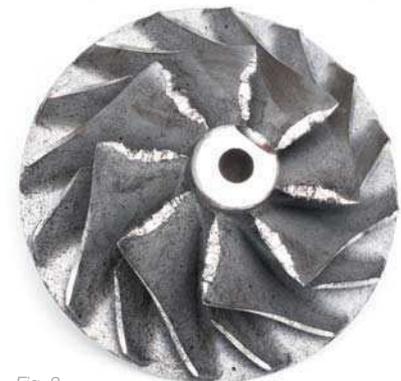
*Fig. 2*  
Impeller damaged by foreign substances

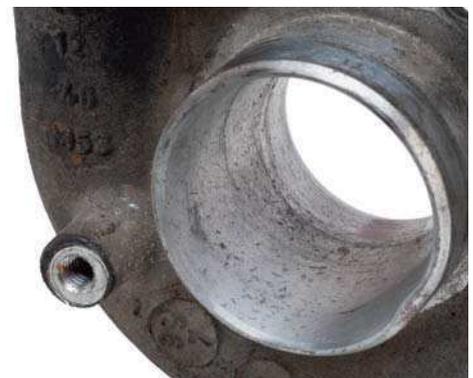
*Fig. 3*  
Foreign substance impact in the intake passage of the compressor housing

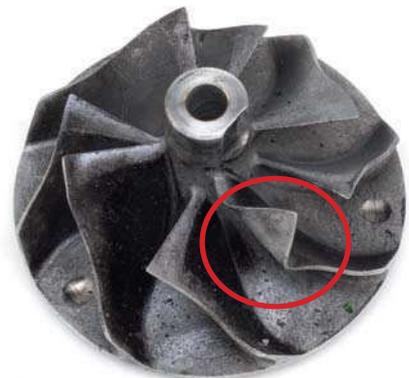
*Fig. 4*  
Only one vane of the impeller damaged

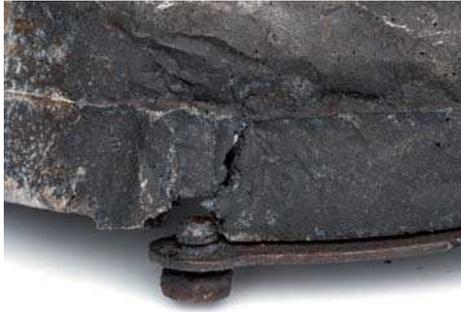
Fig. 1  
Crack in the turbine housing

- Cracks in the housing of the turbocharger (*Fig. 1*).
- Oil lines can become coked: If the supply line is carbonised, the turbocharger will not be sufficiently supplied with oil. If the return line becomes coked, the oil can no longer flow off and oil is forced out of the turbocharger (see also section “4 Oil leakage at turbocharger” on page 10).

- The temperature level has changed due to tuning.
- Combustion faults have occurred in the engine.
- The engine was turned off while still hot.

- The turbocharger may only be installed in the specified vehicles.
- The turbocharger may only be installed and operated in the original state as supplied. Technical modifications are not permitted.
- The engine must always be cooled down at moderate speeds after high stress, such as driving at full load.

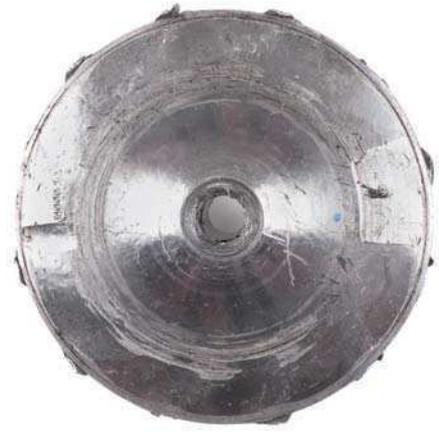
- Small dents can be seen on the rear of the impeller (Fig. 1). The material (mostly aluminium) has deformed plastically due to high centrifugal forces at overspeeds. It begins to flow and the outer diameter increases.
- If the speeds increase further, the impeller can come into contact with the housing and/or break apart (Fig. 2).

- The maximum permissible speed of the turbocharger was exceeded due to tuning.
- The VTG air guide plates become blocked in the position for low speeds due to carbonisation. If the engine speeds are then increased, the turbocharger enters the overspeed range.
- The pneumatic or electric control is defective or leaking.

Fig. 1  
Dents on the rear of the impeller

- The turbocharger must always be left in the original state as supplied.
- The turbocharger may only be installed in the specified vehicles.
- The engine must always be cooled down at moderate speeds after high stress, such as driving at full load.
- Only engine oils specified by the vehicle or engine manufacturer may be used.
- The maintenance intervals according to the manufacturer's recommendations should always be complied with.

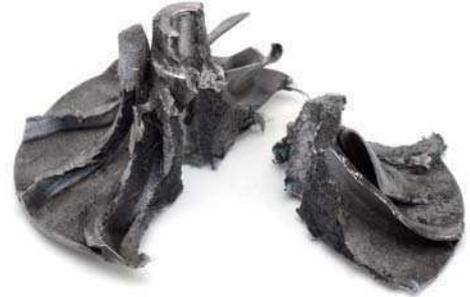
Fig. 2  
Broken-apart impeller
