# Service Bulletin-Cylinder Bores/Liners:

## Failure analysis:

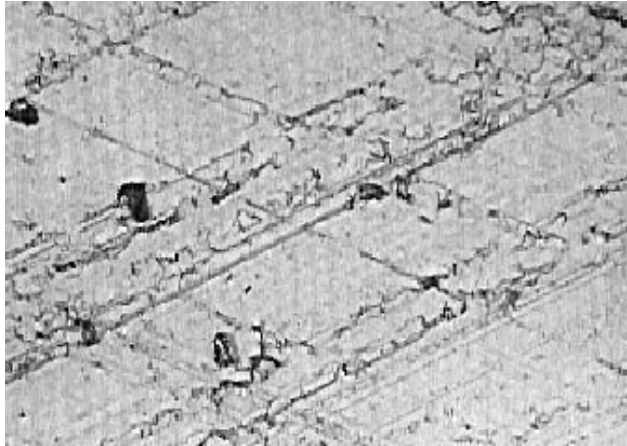
**Folded and torn material**

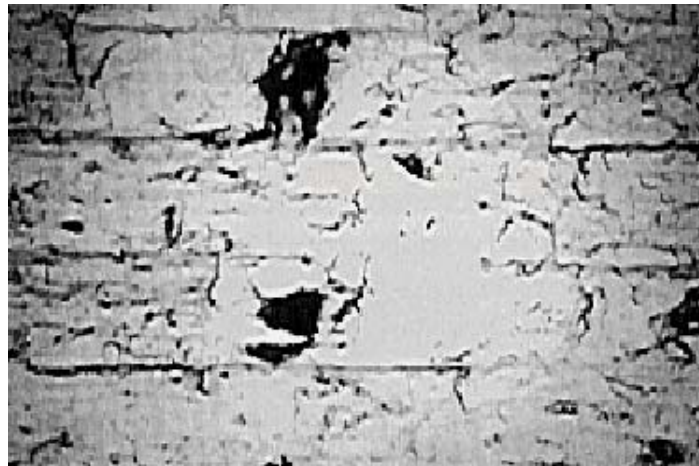
**Turning marks in cylinder bore**

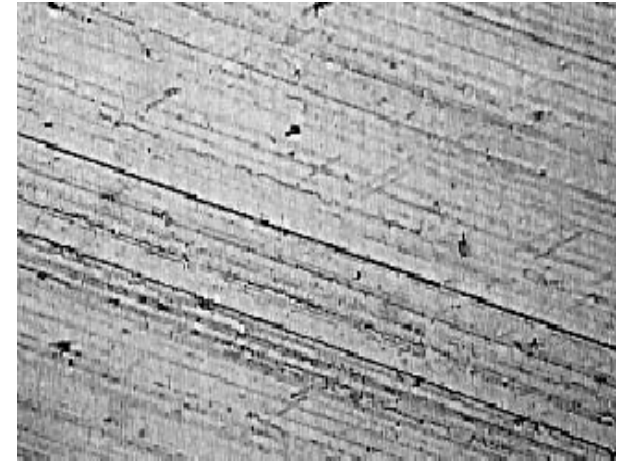
**One-directional x-hatch**

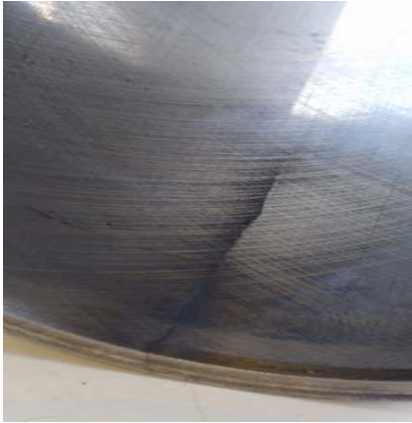
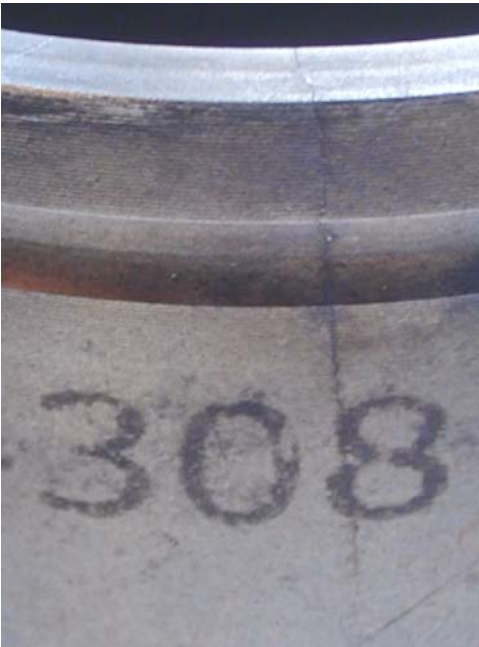
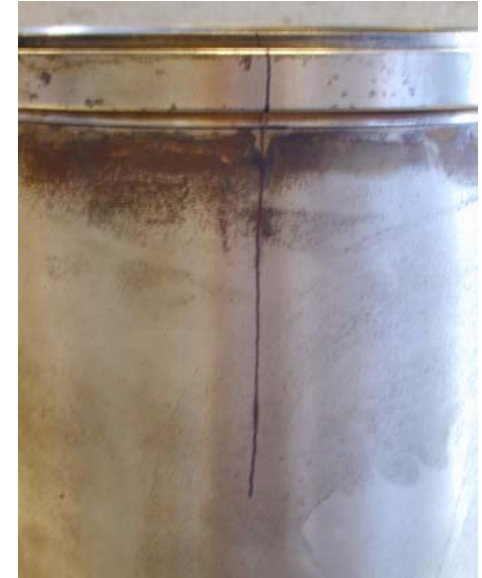
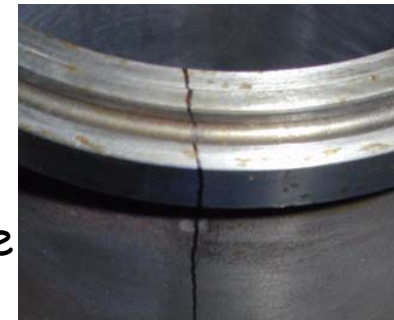
## Longitudinal fractures:

**Appearance:** An almost vertical crack running through (or from) the flange down the body of the liner.

**Cause & effect:** frequently caused by mishandling prior to or during installation. If undetected will propagate during service. Incorrect clamping, damage, distortion or debris on the flange clamping faces can also cause this type of fracture.

**Remedy:** handle cylinder liners with care and check for accidental damage & hairline cracks prior to installation. Ensure that the area where the liner seats in the block and on the head is free from damage or distortion.

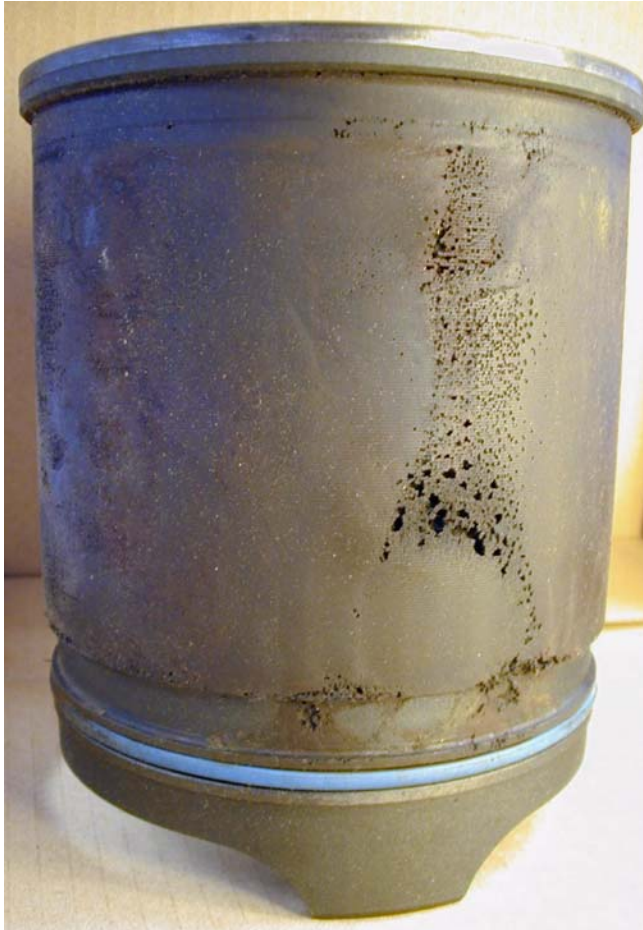
## Cavitation erosion:

**Appearance:** Pitting/erosion of liner material, forming clusters of holes, often in a vertical band on the thrust side. Also found above and below coolant sealing rings. In extreme cases the erosion has been found to penetrate through to the cylinder bore.

**Cause & effect:** Excessive harmonic engine vibrations in conjunction with the coolant flow path result in the formation of bubbles which implode against the liner body, causing material erosion.

**Remedy:** Unfortunately no cost effective material has yet been developed that can withstand cavitation erosion. However, a reduction in the occurrence of cavitation erosion can be gained by reducing the vibrations which cause the problem. I.e. check that the fuel injection system is operating correctly and that engine mountings are in good condition. Check that liner sealing rings are seating correctly and free from any damage and ensure that coolant additives and coolant pressure are correct to manufacturers specifications.

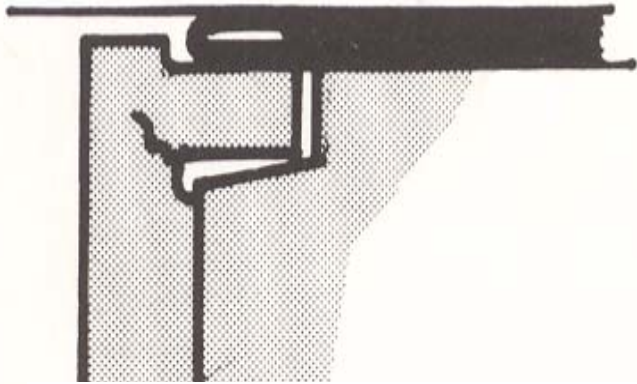
Cylinder block recess out of square.

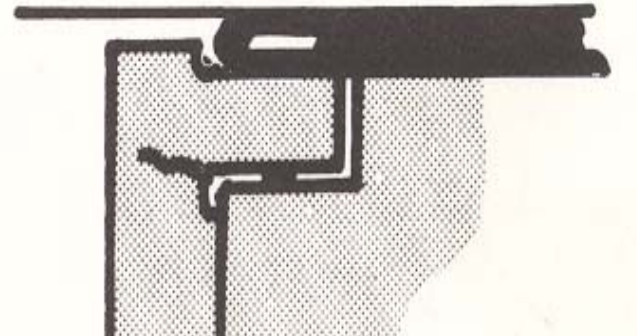
Dirt trapped between the flange and the recess.

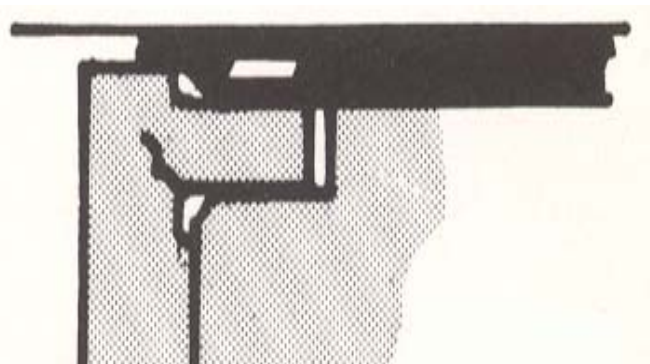
Incorrect location of cylinder head gasket or incorrect gasket for application.

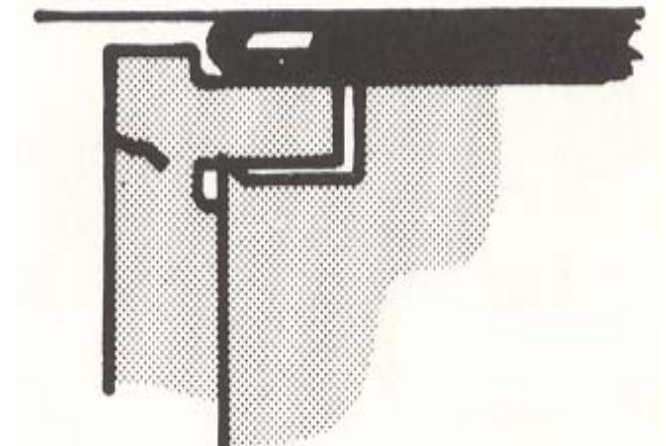
Burr left when machining block counterbore.

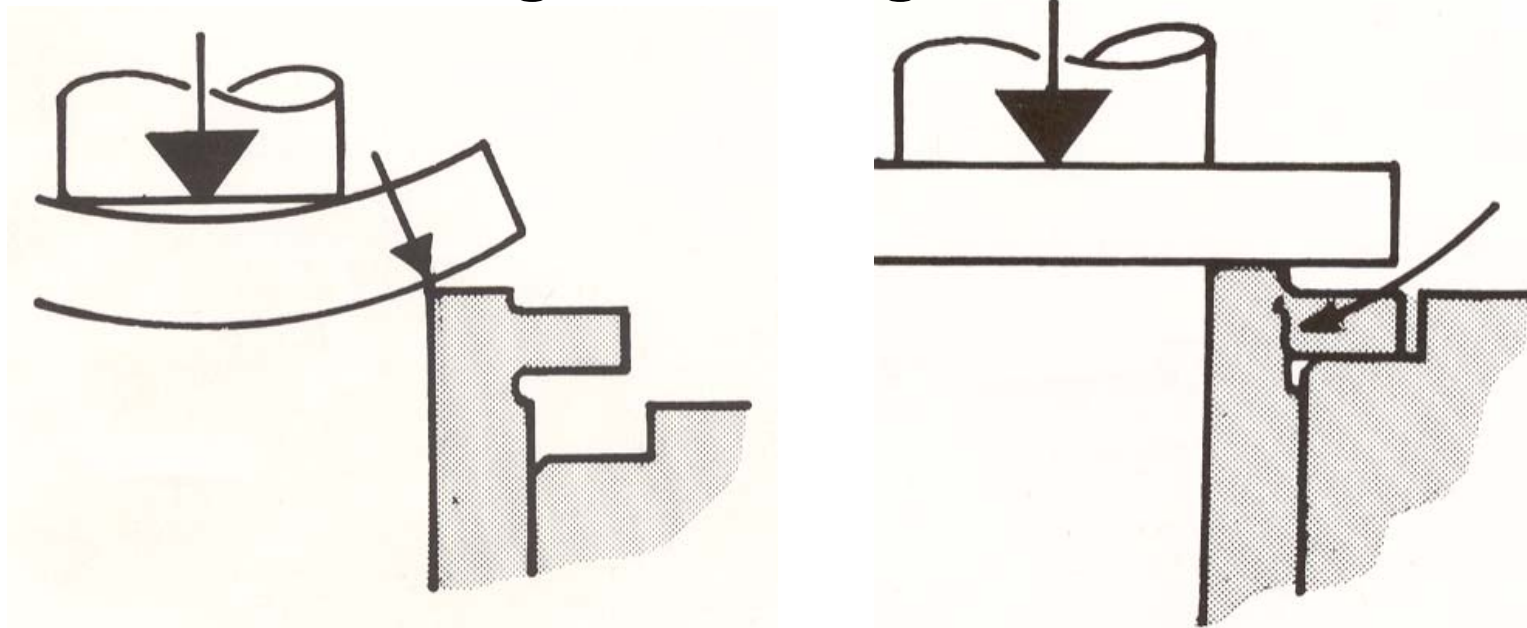
If a press is used to push the liner into position, a rigid plate must be placed between the press and liner. If the plate bows (as shown in the left hand diagram), a bursting stress will be imposed on the liner. Care must also be taken to ensure that excessive pressure is not used which could shear off part of the liner once it has been pushed fully into the block counterbore (see right hand diagram).
