CAMSHAFT TROUBLE TRACER CHART

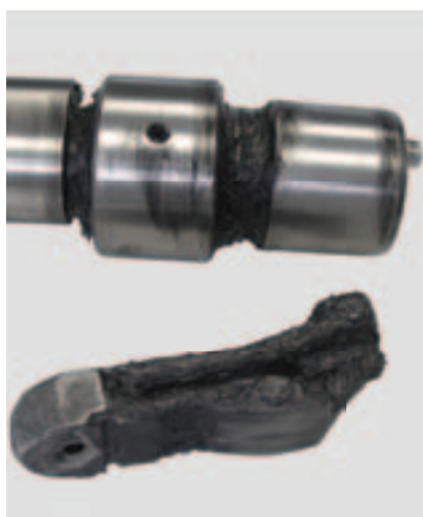
CARBONISED OIL DEPOSITS

Appearance: Carbonised oil build-up on cam and followers.

Causes: Excessive operating temperatures resulting from marginal lubrication conditions due to contaminated lubricating oil or blockages/restrictions in oil feed galleries.

Remedy: Thoroughly flush the lubrication system, ensuring that all galleries and hydraulic lifters (where fitted) are free from blockages and debris. Install new camshaft and followers, prime with extreme pressure lubricant and replace oil and oil filter.

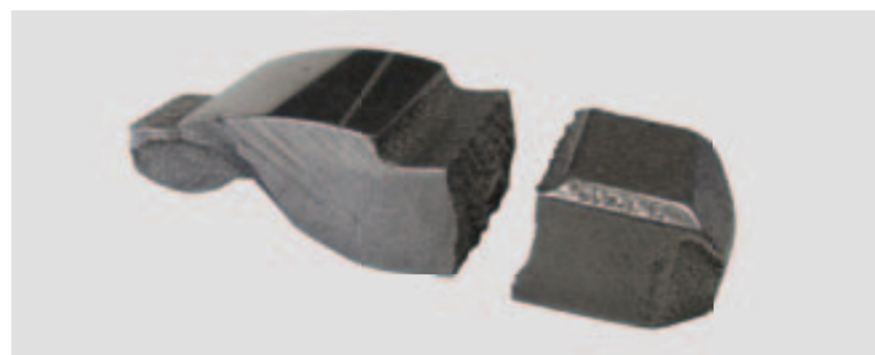
FOLLOWER BREAKAGE

Causes: Mechanical overload resulting from:

- 1 Sticking or seized valve, resulting in the follower to break due to cam-lobe pressure.
- 2 Piston contact with the valve due to:
 - a Weak valve spring
 - b Over extended hydraulic lifter
 - c Incorrect assembly of valve tip-cap
 - d Timing belt breakage
 - e Or through over high revving of engine.
- 3 Incorrect valve timing.

Remedy: investigate and rectify the mechanical overload cause. Thoroughly flush the lubricating system, replace all damage components, prime cam and followers, with extreme pressure lubricant and replace oil and oil filter.

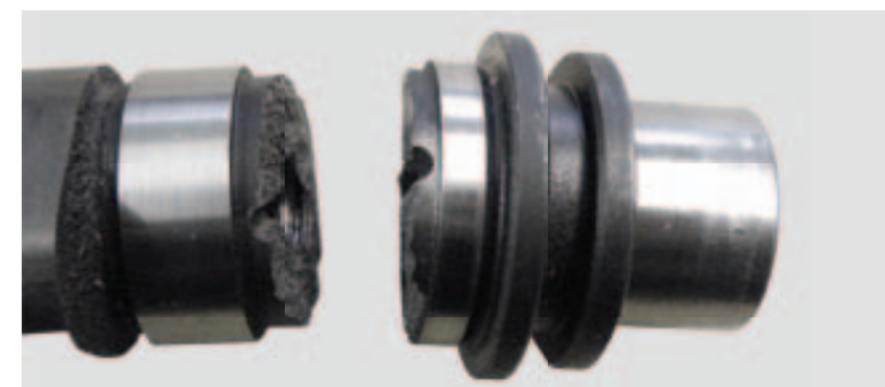
BROKEN CAMSHAFT

Appearance: Camshaft breakage between or through cam-lobes.

Causes: Severe distorted camshaft housing or cylinder head. Incorrect torque sequence and mishandling can also cause similar breakage.

Remedy: Straighten or replace camshaft carrier/cylinder head, use correct bolt torque sequence and handle with care. Thoroughly flush the lubricating system, replace cam and followers, prime with extreme pressure lubricant and replace oil and oil filter.

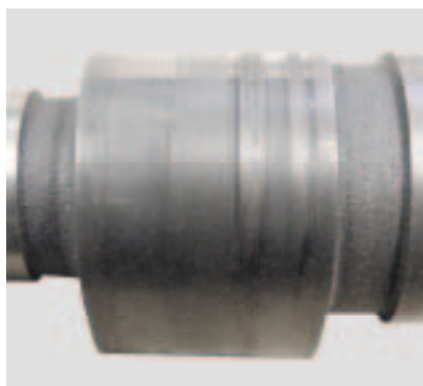
BASE CIRCLE CONTACT MARKING

Appearance: Witness marking on base circle of cam-lobes, biased to one side.

Causes: Worn hydraulic lifter and/or retainer springs.

Remedy: Replace cam and followers if marks are deep, otherwise set tappets to correct clearance. Thoroughly flush the lubricating system and replace oil and filter.

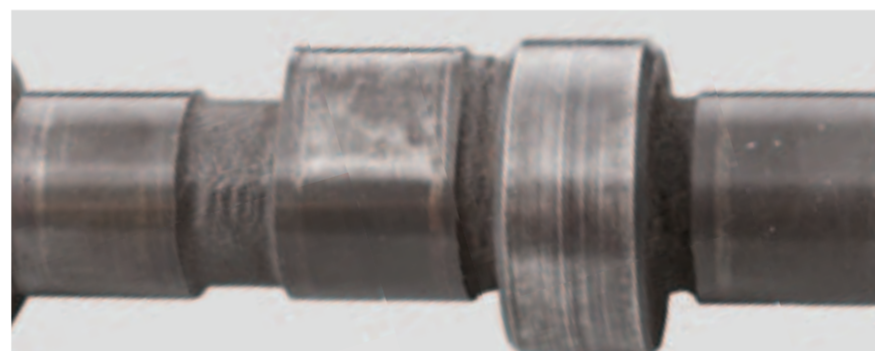
EXCESSIVE CAM-LOBE WEAR

Appearance: Severe cam-lobe wear.

Causes: Contaminated lubricating oil, tappet clearances too tight, excessive valve spring pressure.

Remedy: Thoroughly flush the lubrication system, install new camshaft and followers. Adjust tappets to the correct clearances, prime with extreme pressure lubricant and replace oil and oil filter.

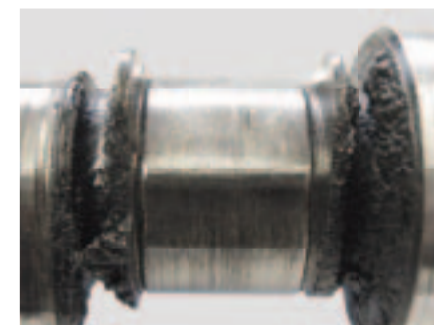
CAM-LOBE AND FOLLOWER WEAR

Appearance: Premature wear of one or more cam-lobes and followers. Follower contact surface will be concaved with chipped edges.

Causes: Incompatible cam-lobe and follower contact surface geometry. Often caused by fitting new camshaft with old followers or vice versa. Can also result from lubricant starvation from blocked or restriction in oil supply.

Remedy: Thoroughly flush the lubricating system, replace cam and followers, prime with extreme pressure lubricant and replace oil and oil filter. Do not mix old and new components.

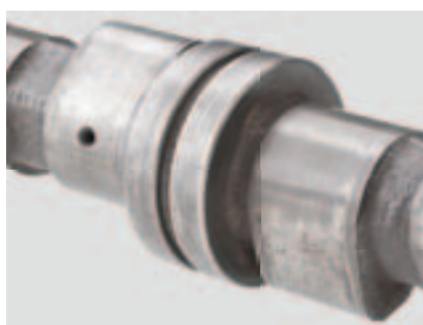
'SCORED' BEARINGS

Appearance: Severe scoring of the camshaft bearings.

Cause: Contaminated lubricating oil, i.e. foreign particles circulating in oil.

Remedy: Thoroughly flush the lubricating system, replace cam and followers, prime with extreme pressure lubricant and replace oil and oil filter.

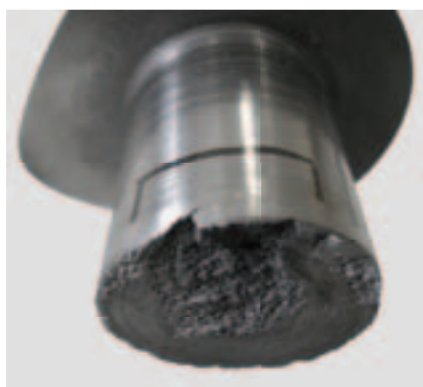
PHYSICAL DAMAGE TO CAMSHAFT AND FOLLOWERS

Appearance: Cam-lobes, bearings and followers "chipped"

Causes: Excessive end-float due to:

- a Worn thrust washer
- b Loose distributor
- c Worn distributor drive gear
- d Or misaligned timing gears

Remedy: Investigate and rectify the cause of the damage. Thoroughly flush the lubricating system, replace cam and followers, prime with extreme pressure lubricant and replace oil and oil filter.

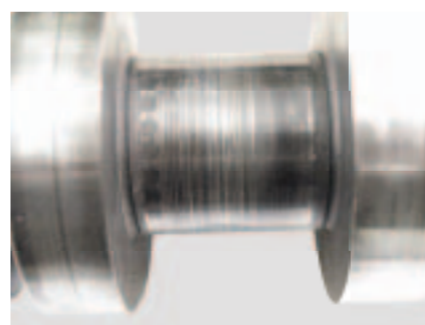
OVERHEATED CAMSHAFT

Appearance: Cam-lobes, bearings and followers have a 'blue' discoloration.

Causes: Severe overheating of engine due to malfunction of the cooling system.

Remedy: Investigate and rectify the cause of the overheating. Thoroughly flush the lubricating system, replace cam and followers, prime with extreme pressure lubricant and replace oil and oil filter.
