Service Bulletin - Piston Rings:

Piston ring failure diagnosis - foreign particle contamination:

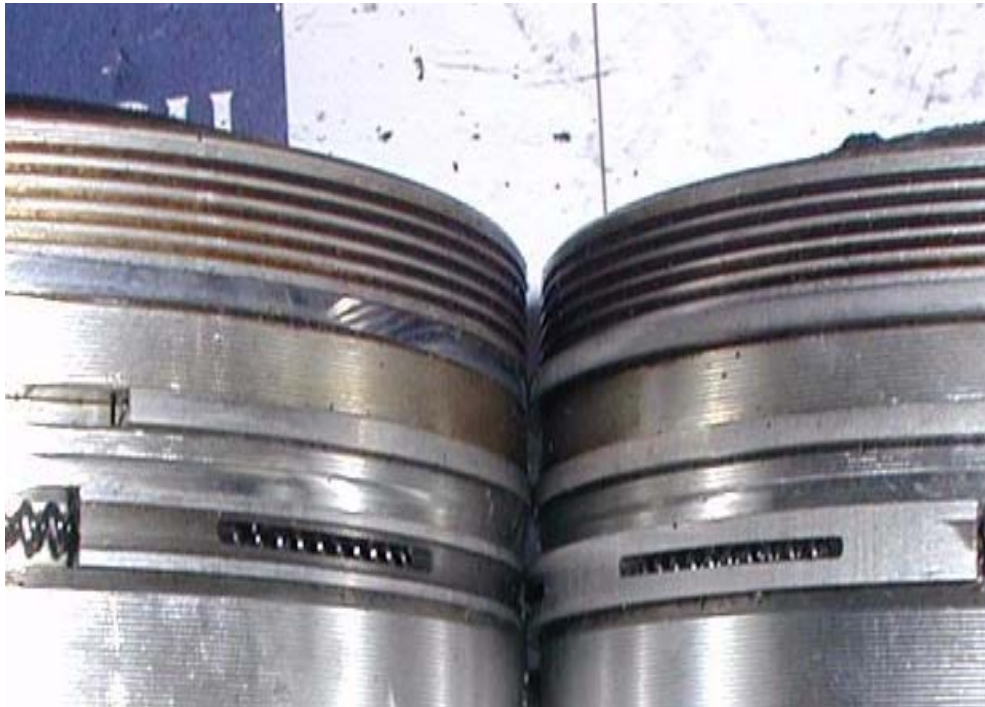
Note: oil ring lands worn away on right hand piston.

Running surface worn, Ring flanks scored
Ring grooves badly worn
Liner surface scored

Solid particles / debris in engine.
Insufficient cleaning of liner surface after honing.

Oil consumption, oil smoke from stack
Scoring marks on liner surface
Blow - bye

Thorough cleaning of liner surface after honing,
Check oil maintenance system / filters,
Clean engine lubrication system before refilling with new oil.

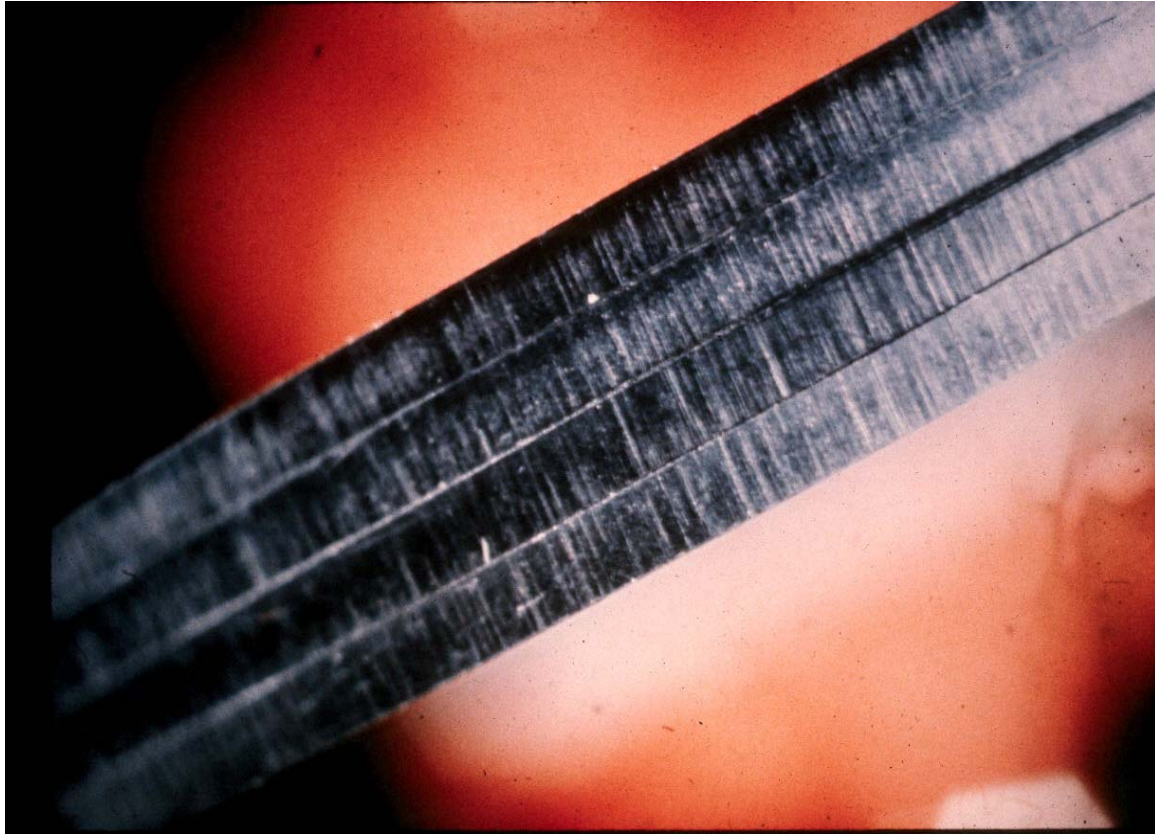
Piston ring failure diagnosis - incorrect bore finish:

Running surface of rings scored & torn

Bore surface finish too coarse.

Honing angle incorrect.

Oil consumption, smoke from exhaust

Scoring marks on liner surface

Blow - by

Check boring equipment & specifications for correct bore surface finish.

Check oil maintenance system / filters,

Clean engine lubrication system before

refilling with new oil.

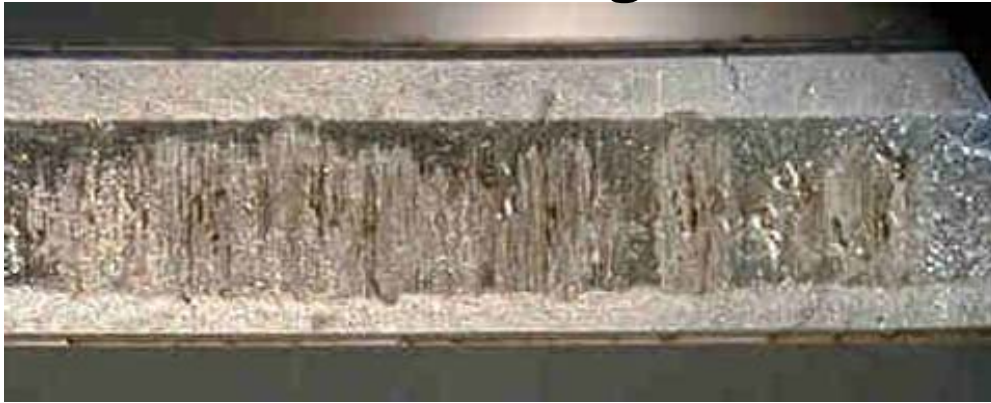
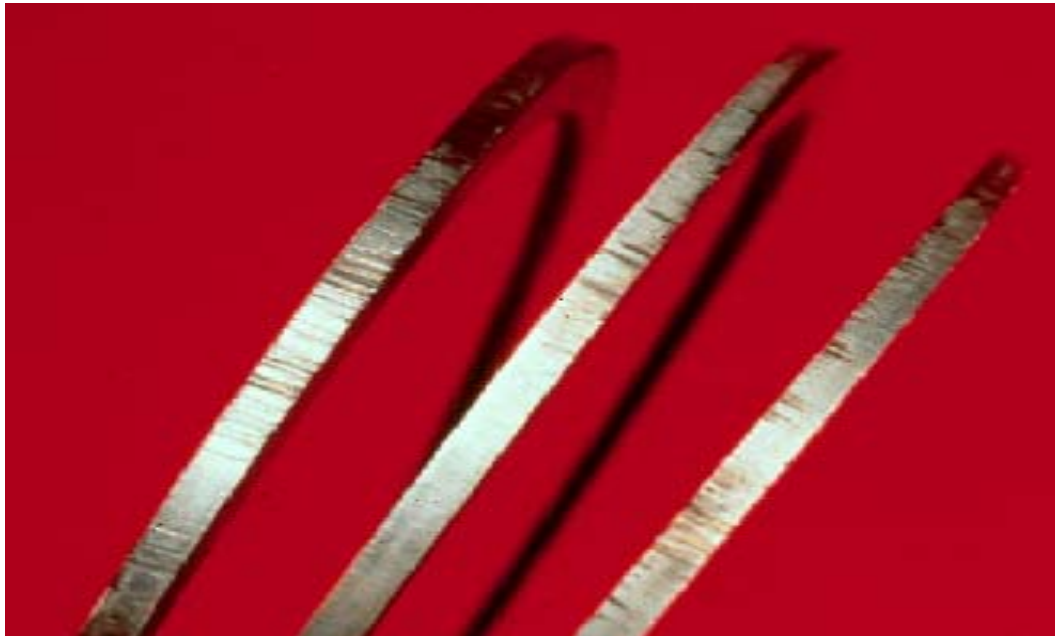
Piston ring failure diagnosis - scuffing:

Running surface scuffed, worn

Lack of lubrication,

Dry start of engine after ring installation,

Glaze on liner surface

Liner roundness fault

Oil consumption,

Oil smoke from exhaust

Scuffing marks on liner surface

Blow - by

Correct reconditioning of liner surface,
oil-wettening of liner and rings before
assembly

Control engine lubrication system.

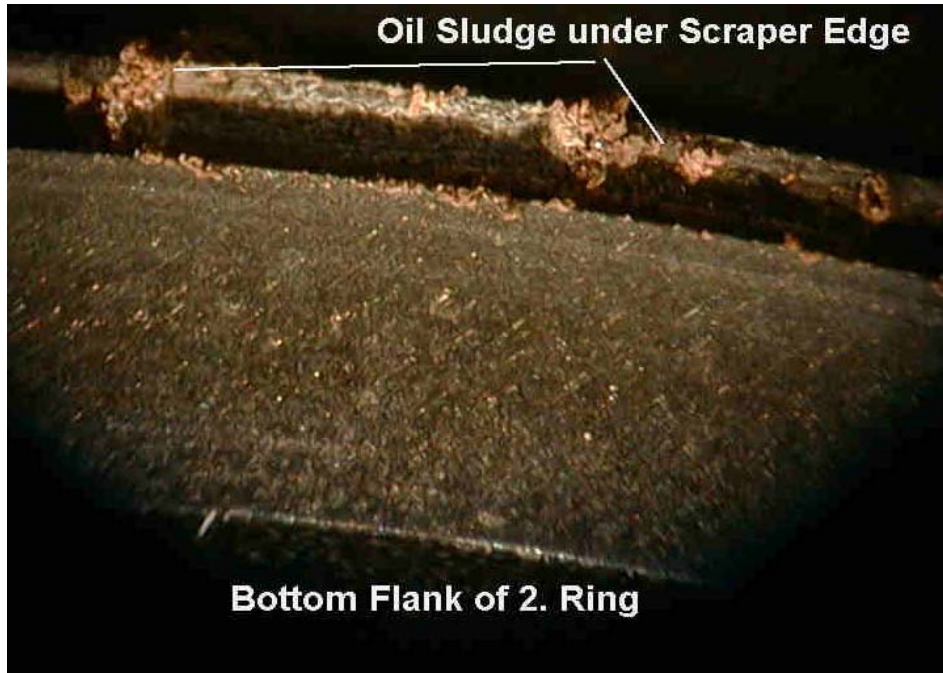
Piston ring failure diagnosis - high oil consumption:

Oil sludge deposits on scraper edges

Engine oil overaged,
Oil contamination with water

Oil consumption,
Oil smoke from exhaust

Check engine lubrication system,
Check cooling system for leaks.
Clean engine lubrication system before
refilling with new oil.

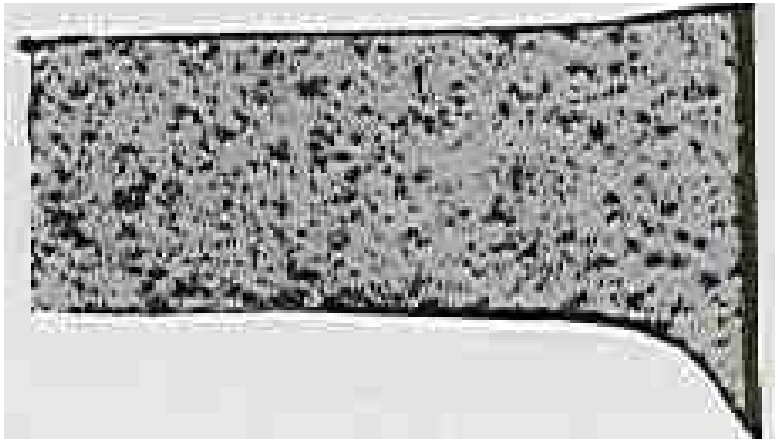
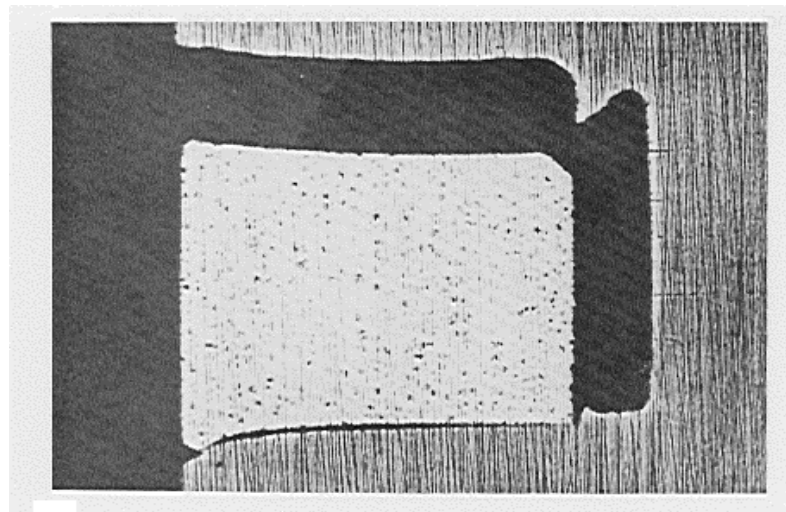
Piston ring failure diagnosis - ring/groove side face wear:

Accelerated wear on side faces of rings (worse on lower side) and ring grooves (compression rings in particular. Other rings may be affected to a lesser degree.

Liquid fuel degrading lubricant in ring grooves.

Solid residue from honing erodes flank material.

Oil consumption. Loss of power.

Ensure that fuel mixture is correct, that the choke is not abused or sticking, manifold raw fuel drain is clear, air filter is not blocked or choked.

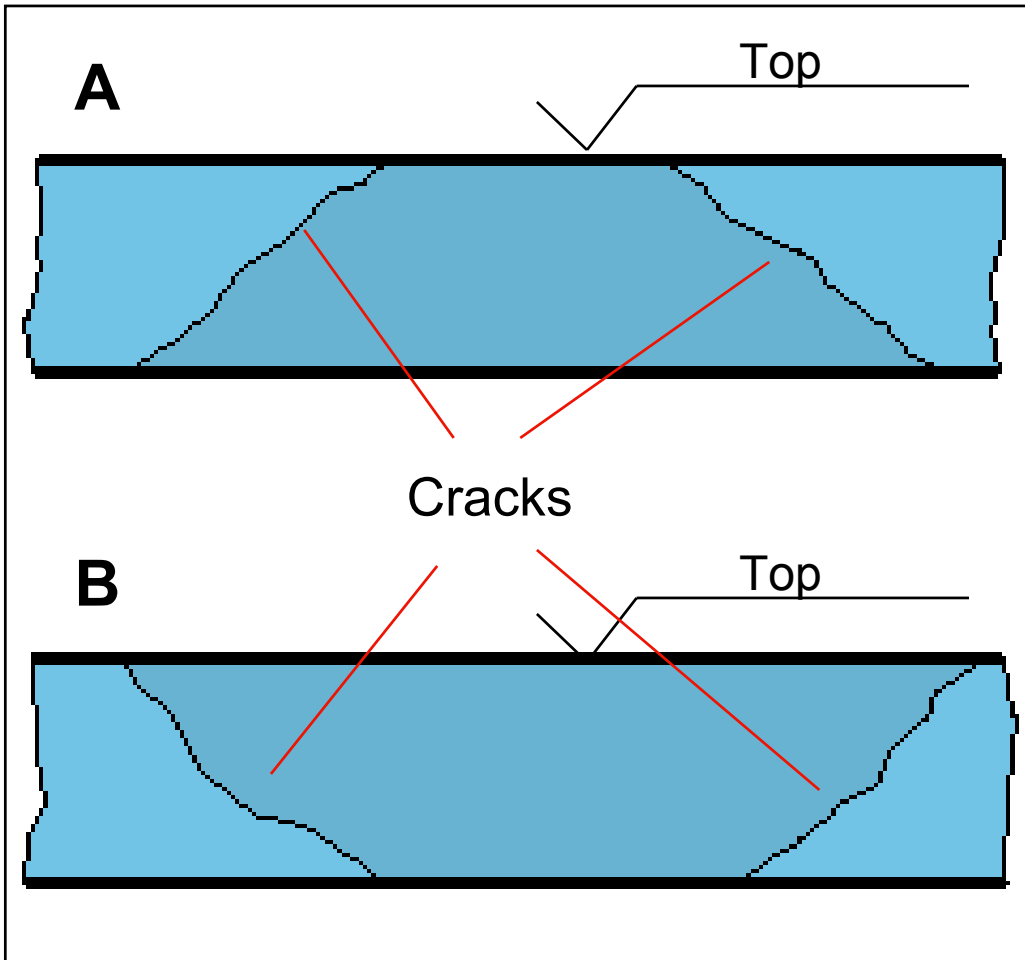
Piston ring failure diagnosis - cracked rings:

Ring fracture

Excessive gas pressure.

Worn-out ring groove.

Installation fault.

Oil consumption, loss of power

Oil smoke from exhaust

Check engine combustion.

Check ring grooves in piston

Use piston ring expander tool to prevent over-stressing rings during installation.

Remove ridge on upper edge of cylinder before inserting piston.

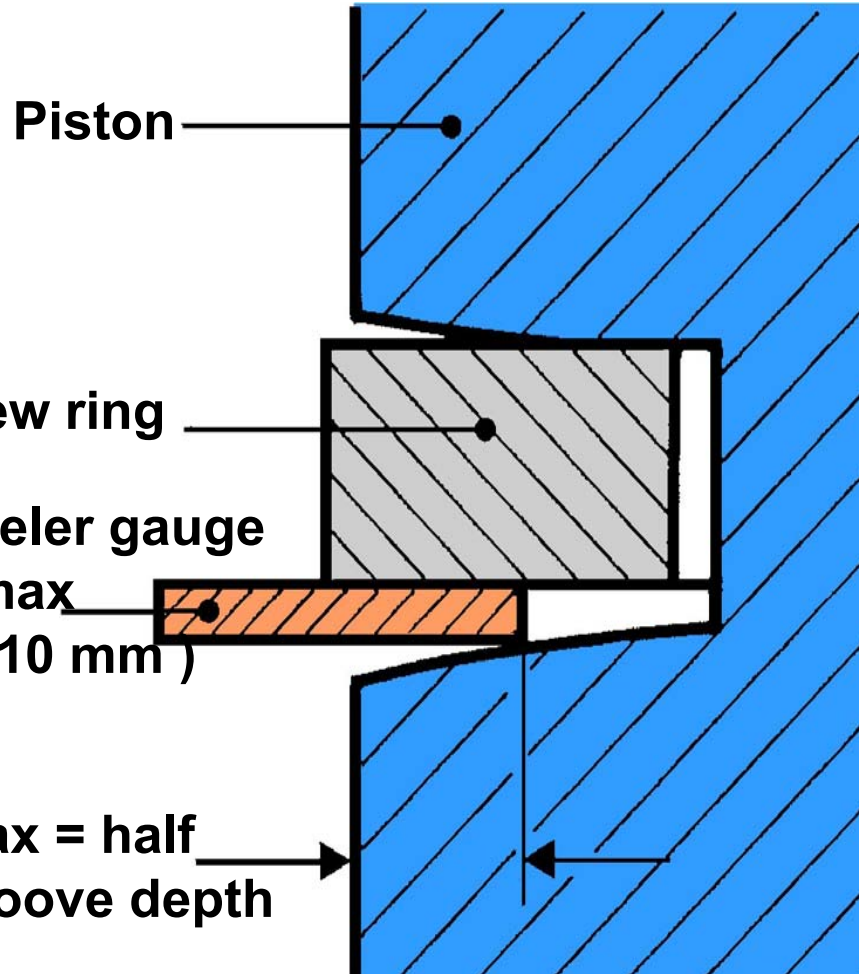
Piston ring failure diagnosis - wear limits:

Parallel rings/grooves

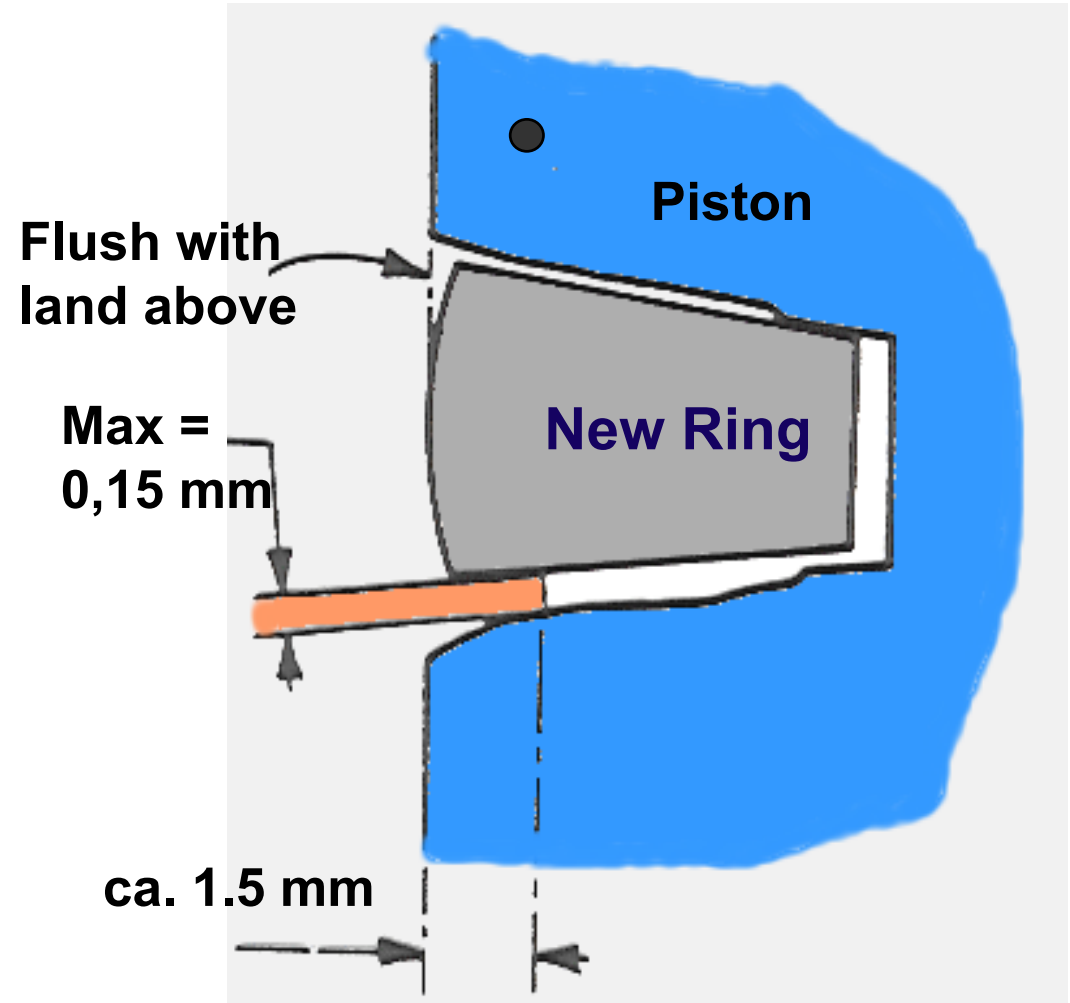
Keystone rings/grooves
