# Service Bulletin-Cylinder Bores/Liners:

## Failure analysis:

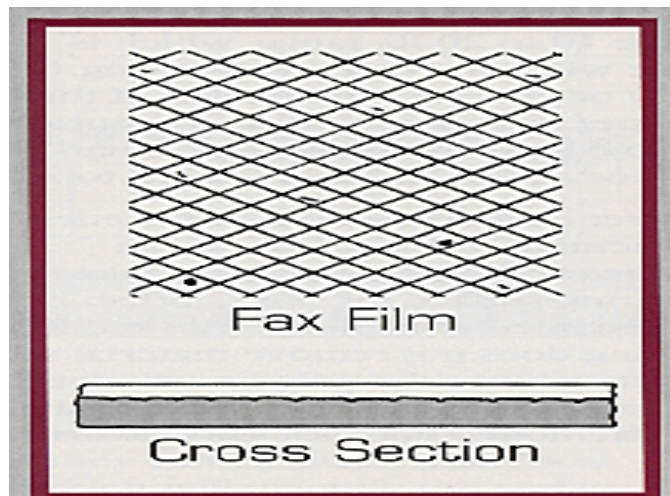
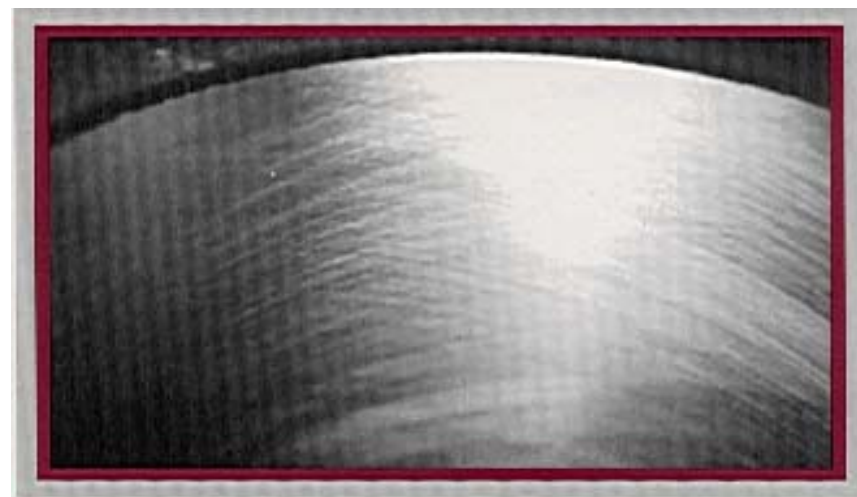
## Bore finish recommendations:

- Cross hatch angle 120°(included)
- Uniform cut in both directions
- Clean cut: free of torn and folded material
- Plateau profile; Ra = 0,6 - 1,2  $\mu\text{m}$
- Free of burnish or glaze
- Free of embedded particles
