# TROUBLE TRACER CHART

## VALVE OPERATING CONDITIONS

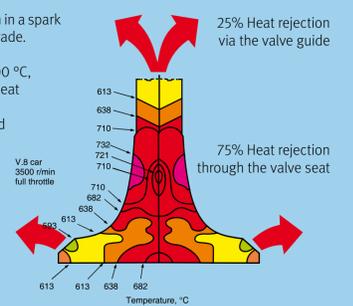
Typical exhaust valve temperature distribution in a spark ignition engine. Figures are degrees in centigrade.

- An exhaust valve may operate at up to 800 °C, and 75% of its cooling is by transferring heat to the valve seat.
- Ensure the valve seat contact is correct and as specified by the engine manufacturer.
